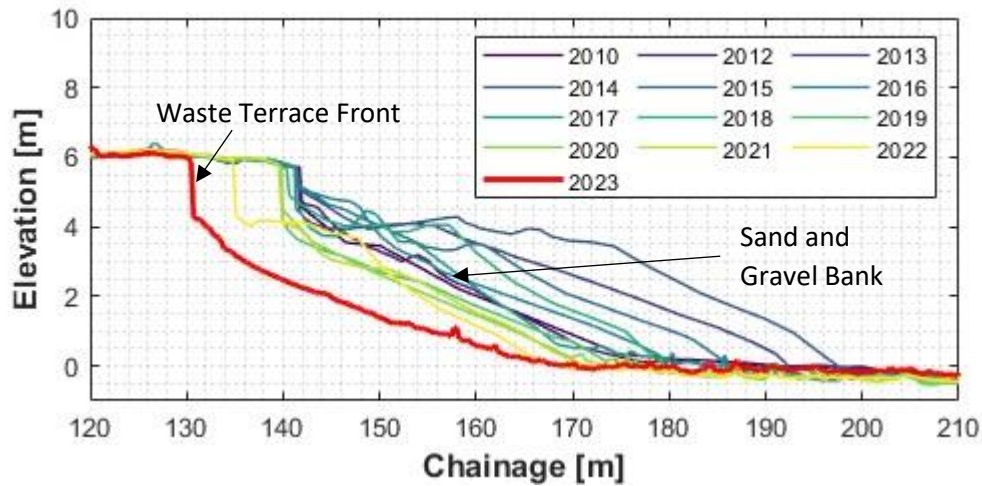
Fig 1. Time series of Seaham Beach waste terrace profiles from 2010 up to Nov 2023 [6]. Changes following Storm Babet (2022-2023), include significant loss of the protective sand gravel banks (0-4m elevation; 140-170m) previously present in front of the waste terrace, and significant total retreat of the waste front (at 4-6m) from ~135 to ~130m. The previous erosion due of Storm Arwen (26-27 Nov 2021) and the 2021-22 winter season are also visible between 2021 and 2022.
